# Storm Induced Beach Profile Changes along the Coast of Treasure Island, West-Central Florida, U.S.A.

A thesis submitted in partial fulfillment  
of the requirements for the degree of  
Master of Science  
School of Geosciences  
College of Arts and Sciences  
University of South Florida

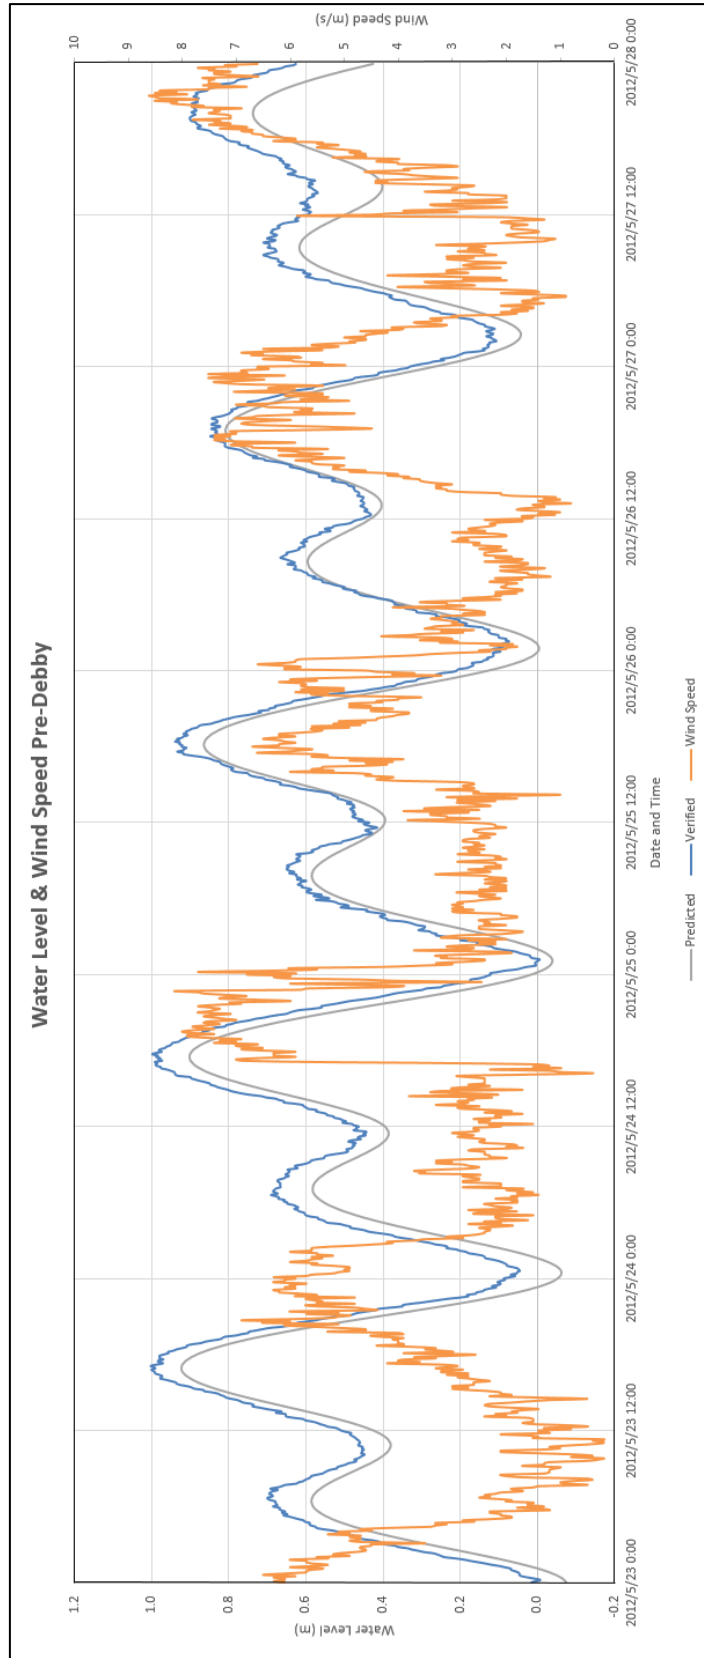
**Figure 27.** Water level and wind speed pre-tropical storm Debby, 23-28 May, 2012.

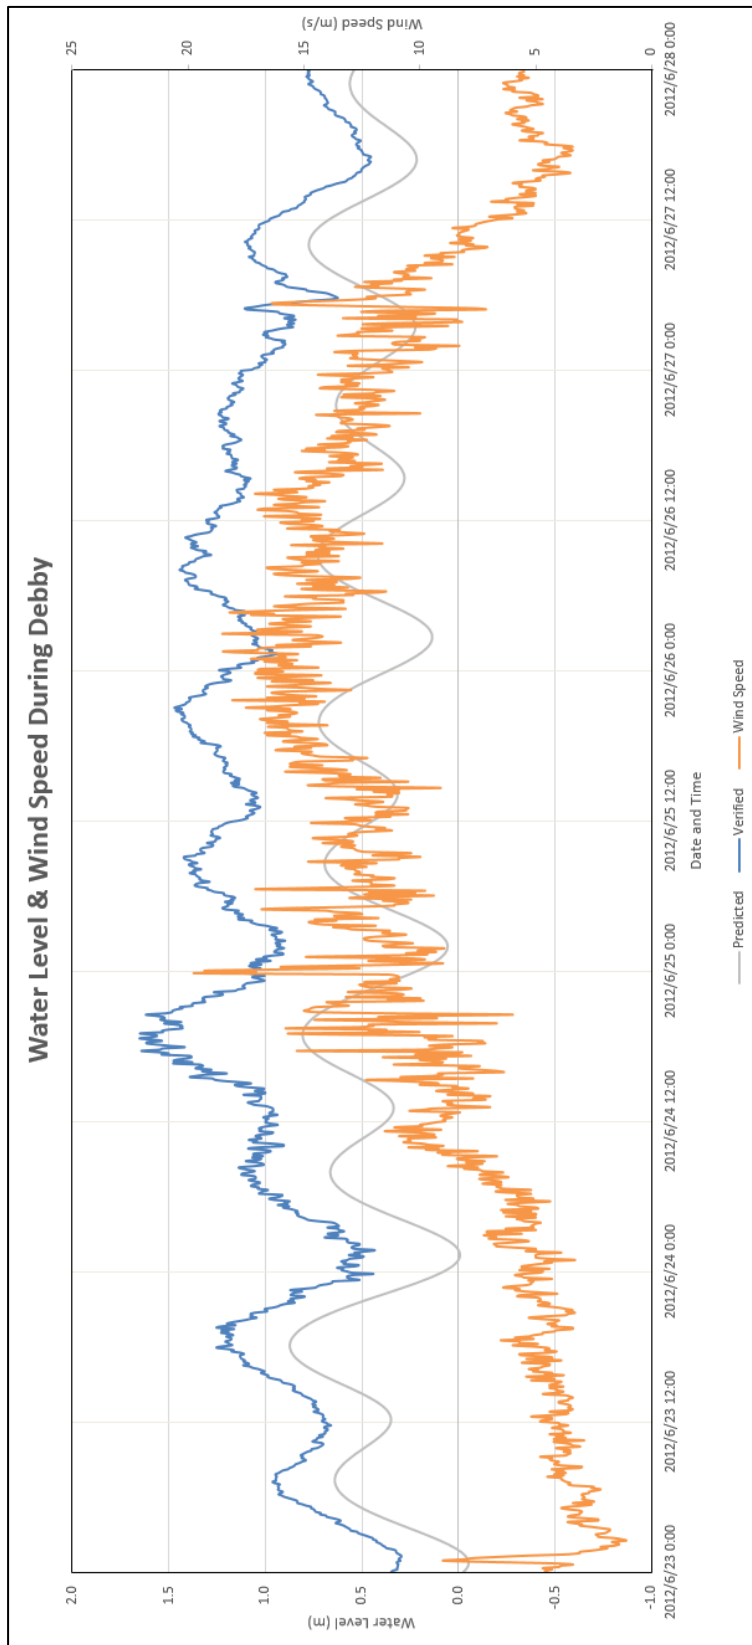
**Figure 28.** Water level and wind speed post tropical storm Debby, 23-28 May, 2012.

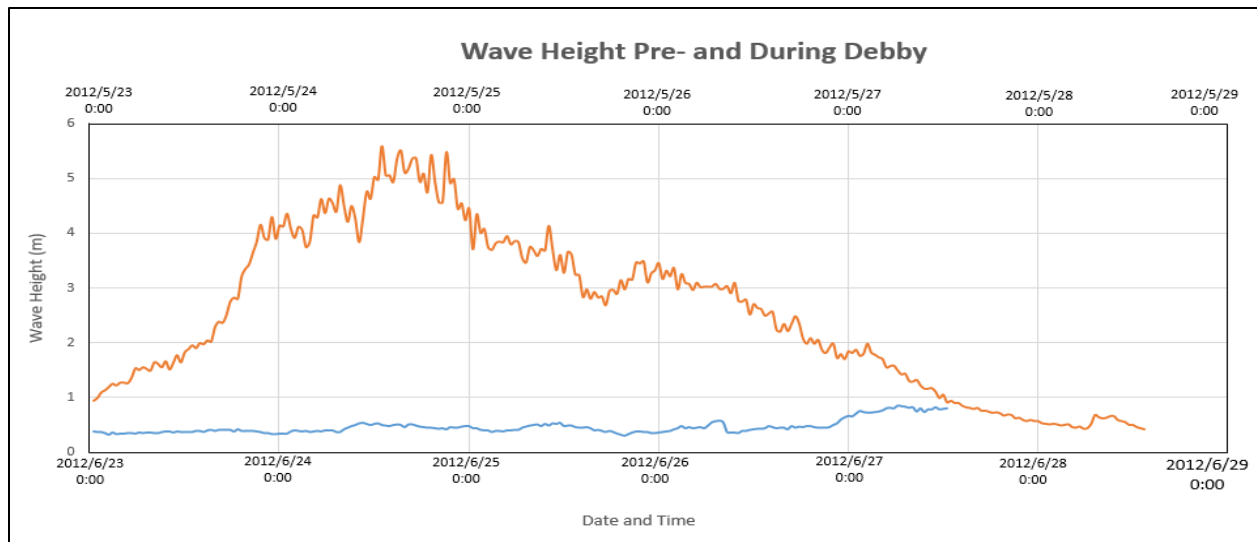
**Figure 29.** Wave height changes pre- and during tropical storm Debby.

Superimposed on strong winds and high storm surge, energetic waves played a significant role in eroding the Treasure Island beach. Figure 29 (See page 40) illustrates wave height changes during tropical storm Debby and one month before Debby, respectively. When the storm was formed on June 23<sup>rd</sup>, wave height increased rapidly from 1 m to 4 m. Wave height reached the maximum of 5.06 m the next day. From June 25<sup>th</sup> to 27<sup>th</sup>, wave heights decreased slowly, however, wave height was still much higher than the normal level. After Debby moved inland, wave height decreased to the pre-storm level.

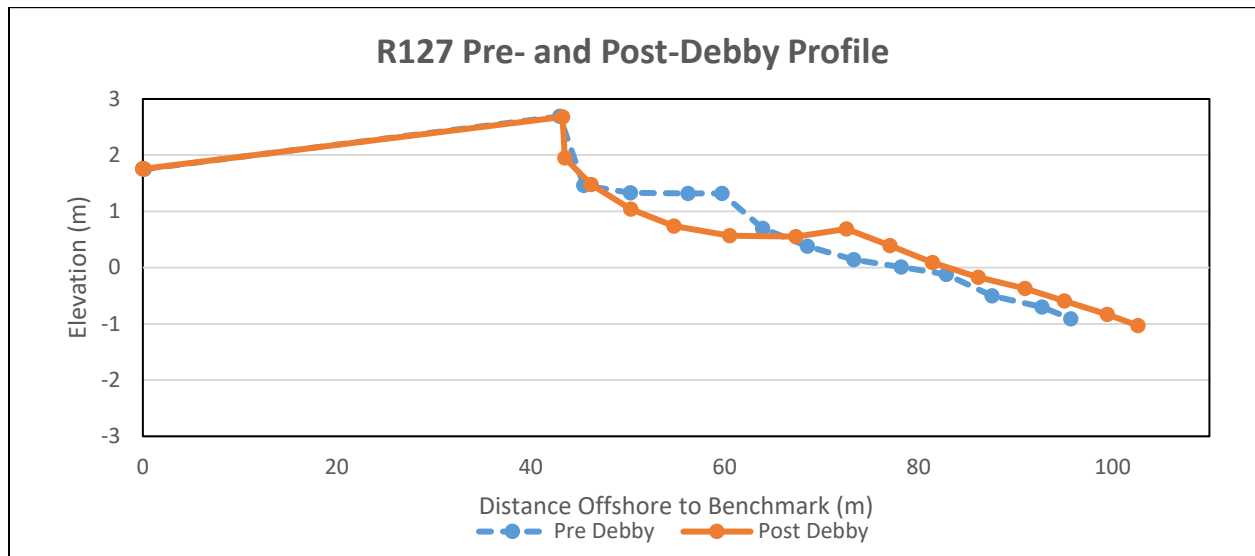
**Figure 30.** Beach profile change at survey line R127 due to Debby.

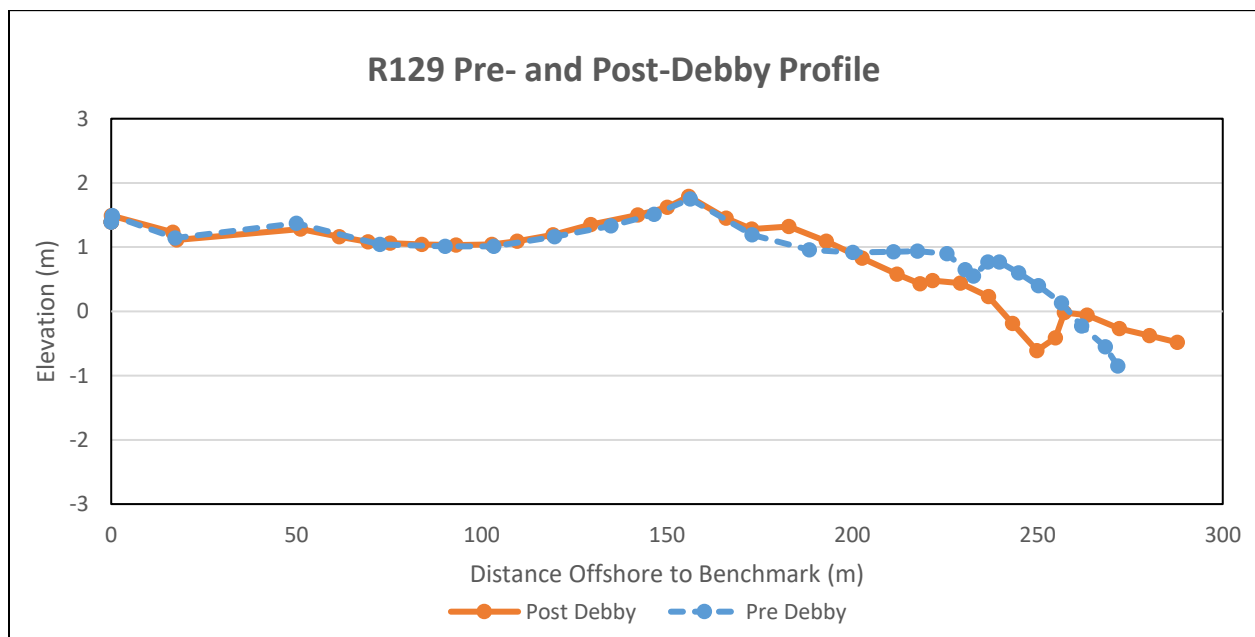
**Figure 31.** Beach profile change at survey line R129 due to Debby.

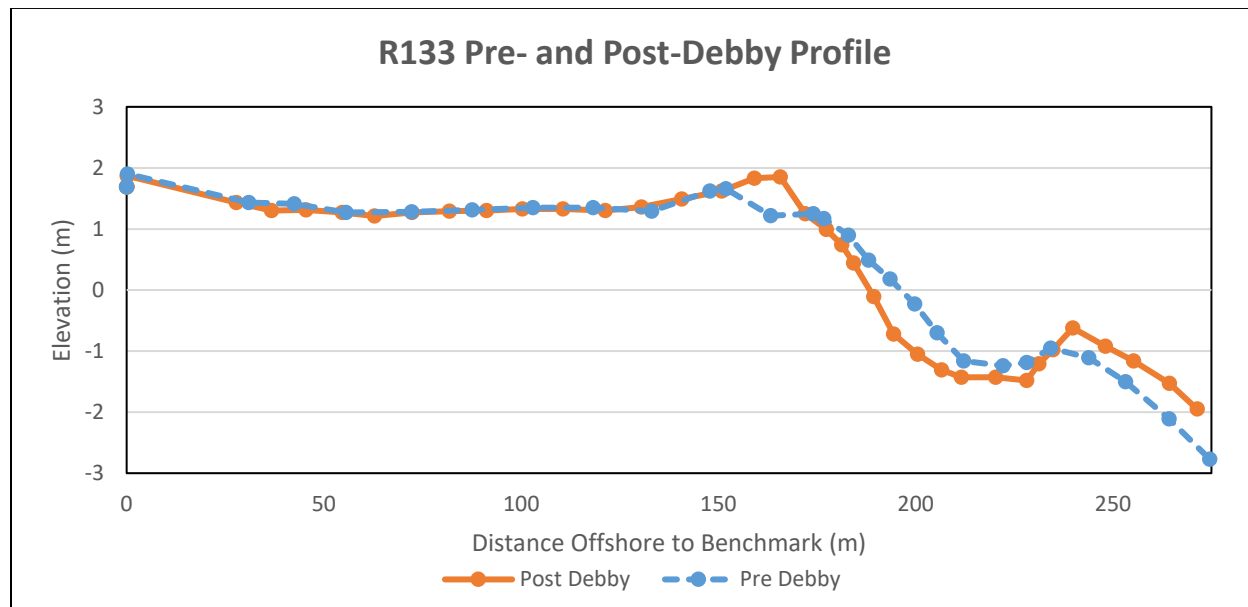
**Figure 32.** Beach profile change at survey line R133 due to Debby.

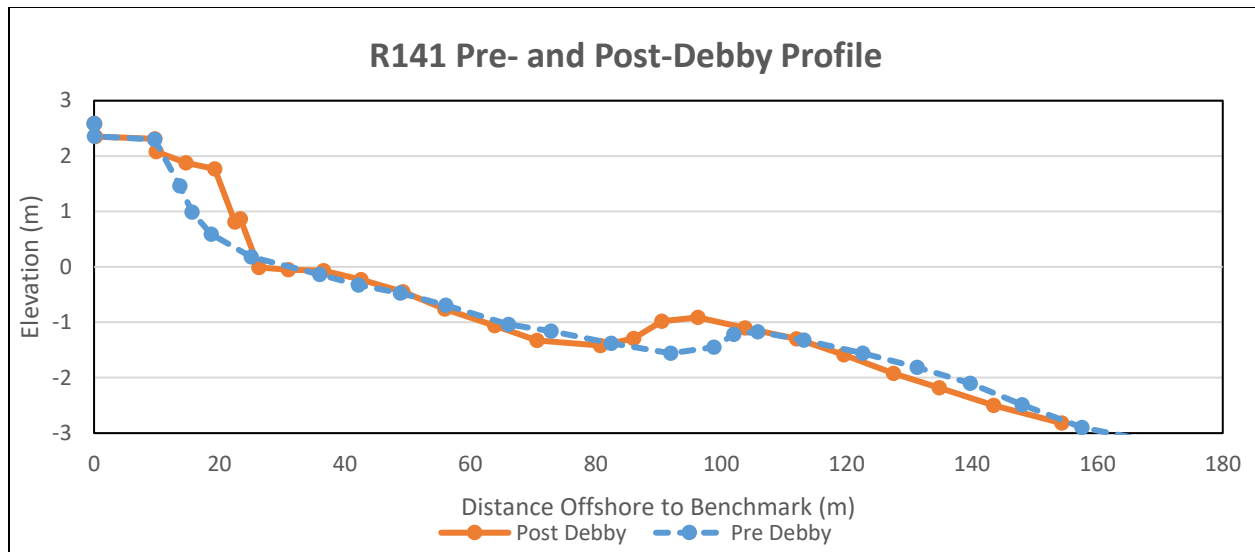
**Figure 33.** Beach profile change at survey line R141 due to Debby.

A dune scarp was formed at profile R141 (Figure 33). The nearshore zone experienced slight erosion. The sandbar crest moved onshore approximately 13 m. The offshore zone was also slightly eroded. At the elevation of 1.0 m, the profile moved seaward approximately 8 m and a scarp was formed; at the elevation of 0.0 m, the contour line retreated approximately 3 m landward; and at the elevation of -1.0 m, the sand bar moved landward approximately 13 m.

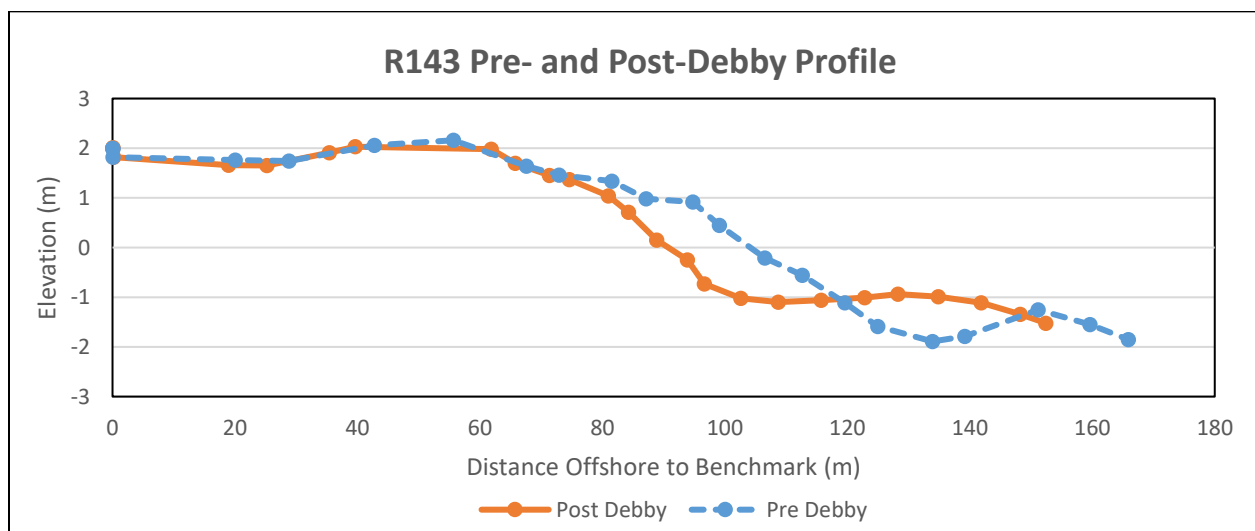
**Figure 34.** Beach profile change at survey line R143 due to Debby.

At the southernmost part of Sunset Beach, survey line R143 experienced severe erosion (Figure 34), and the nearshore zone lost a large amount of sediment. At the elevation of 1.0 m, the contour line retreated approximately 8 m landward. At elevation of 0.0 m, the contour line moved approximately 12 m landward. At elevation of -1.0 m, the contour line retreated approximately 20 m landward. Overall, measured sand loss was approximately 20 m<sup>3</sup>/m.

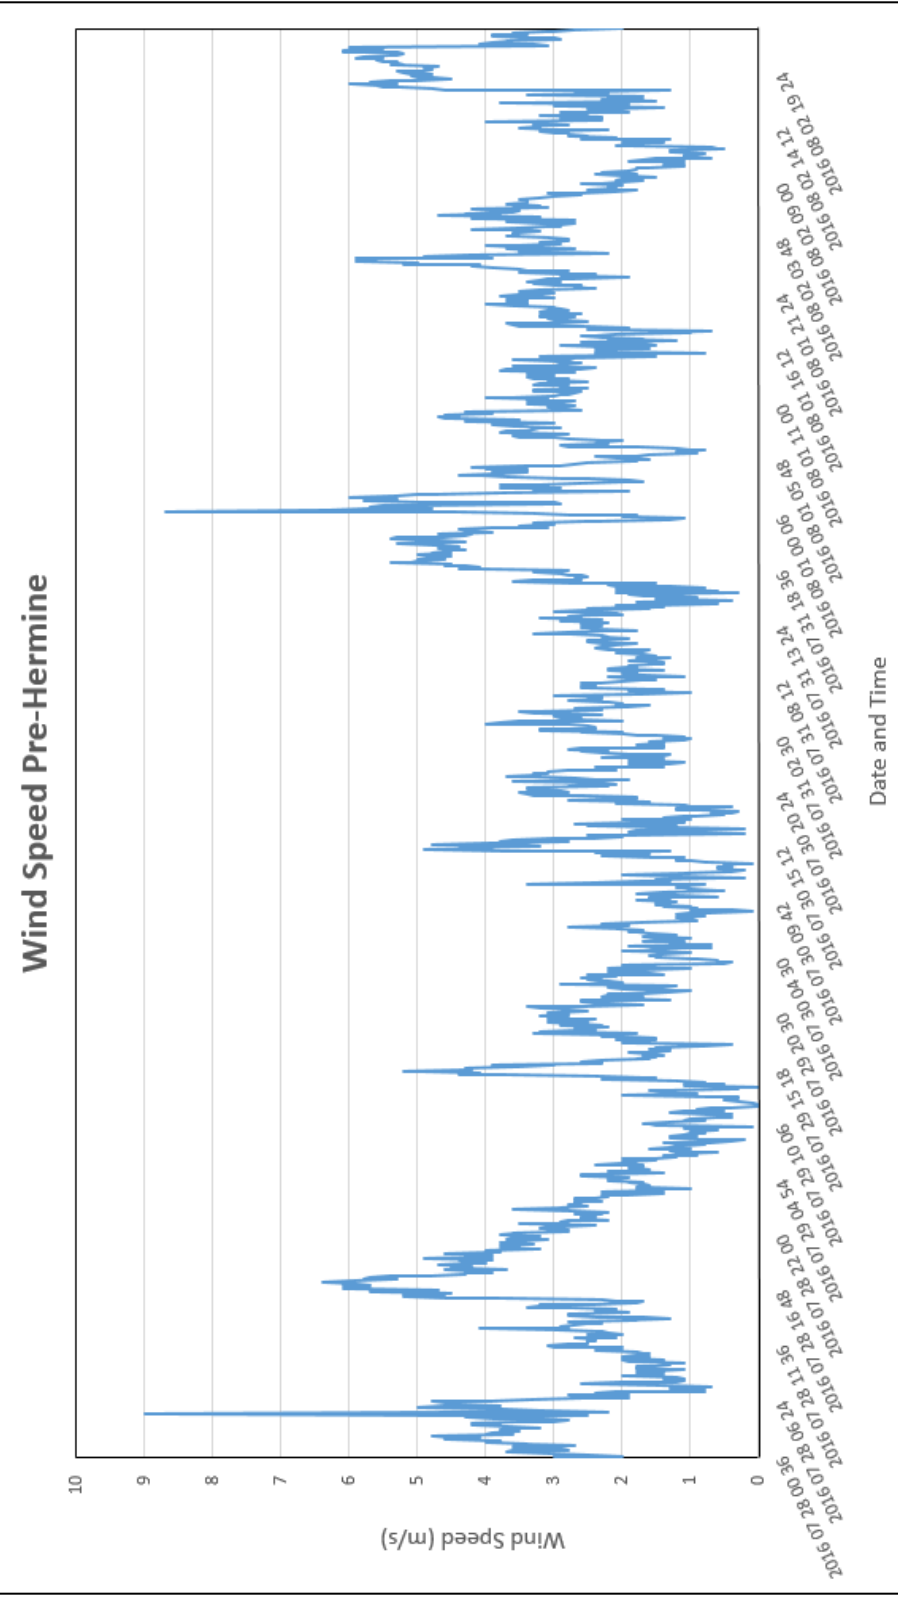
Figure 36. Wind speed pre-Hermine, July 28<sup>th</sup> – August 2<sup>nd</sup> , 2016.

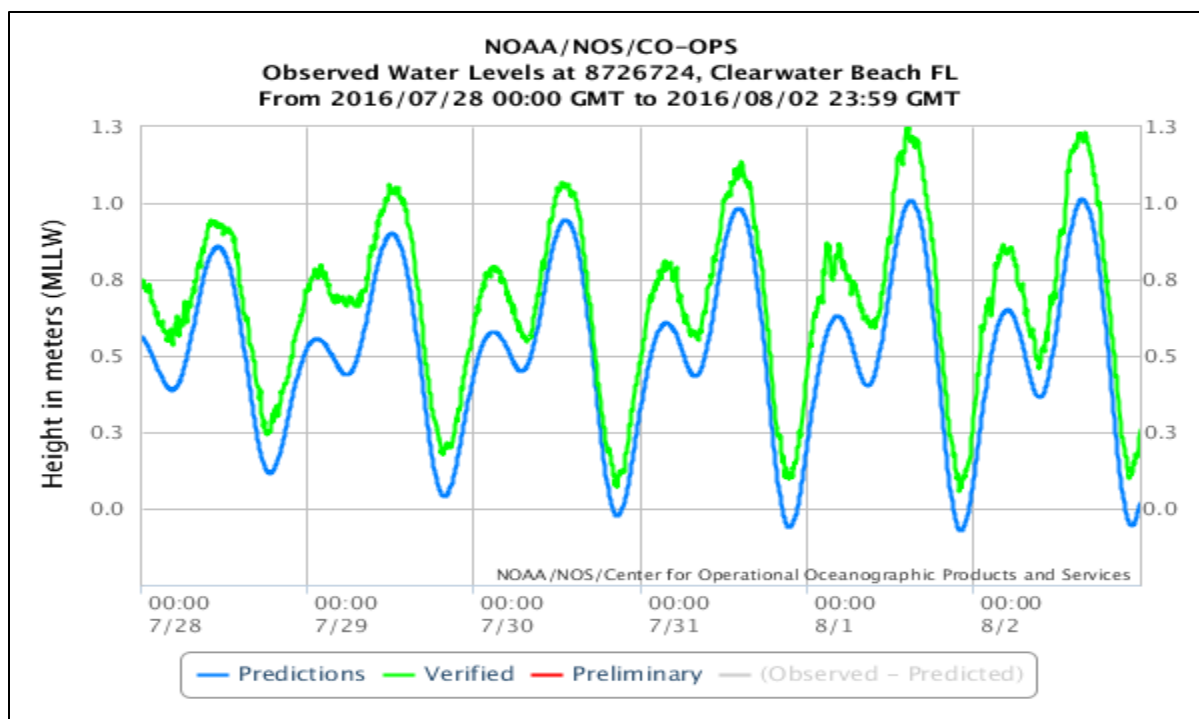
**Figure 38-1.** Water level pre-Hermine, July 28<sup>th</sup> to August 2<sup>nd</sup>, 2016 (NOAA).

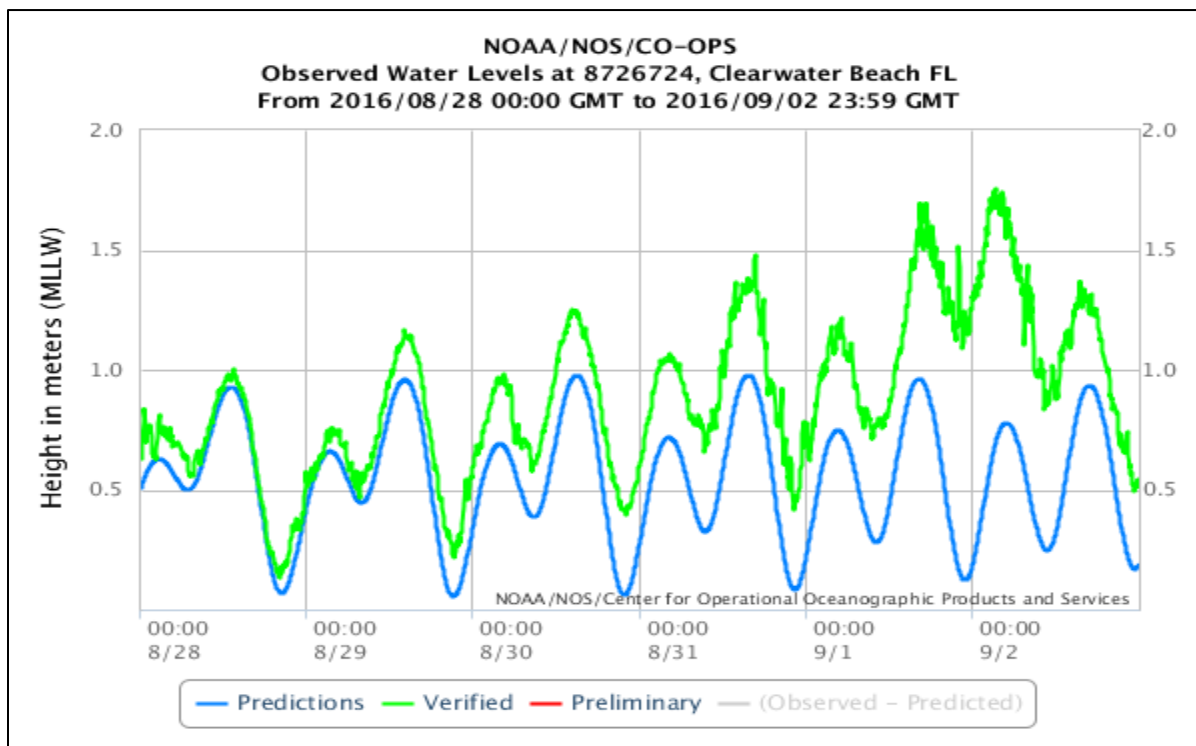
**Figure 38-2.** Water level during Hermine, August 28<sup>th</sup> to September 2<sup>nd</sup>, 2016 (NOAA).

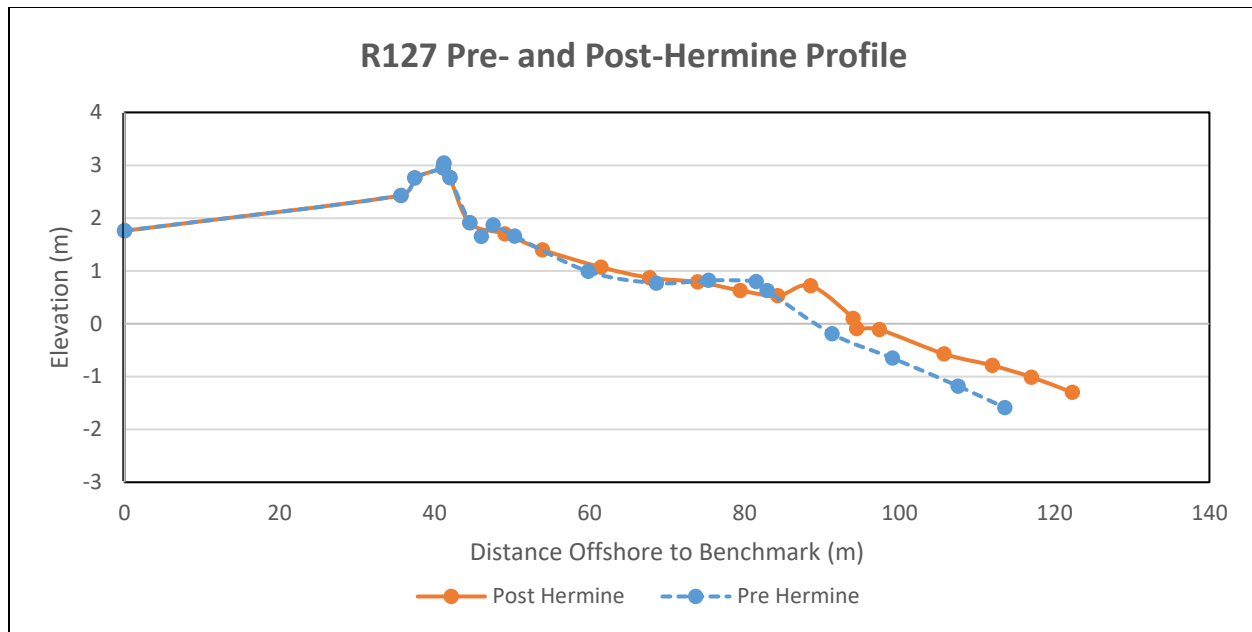
**Figure 39.** Beach profile change at survey line R127 due to Hermine.

The pre-storm berm crest was eroded away at survey line R127 at a location approximately 47 m seaward from the benchmark, but no scarp occurred at the dune (Figure 39, see page 50). The nearshore zone received sediment deposition which was probably caused by the impoundment of northerly longshore sediment transport, generated by the highly oblique southerly incident wave. At the elevation of 1.0 m, the dry beach moved seaward for approximately 2 m; at the elevation of 0.0 m, the coastline moved approximately 5 m seaward; and at the elevation of -1.0 m, the nearshore zone moved approximately 12 m seaward. Overall, beach accretion occurred at survey R127.

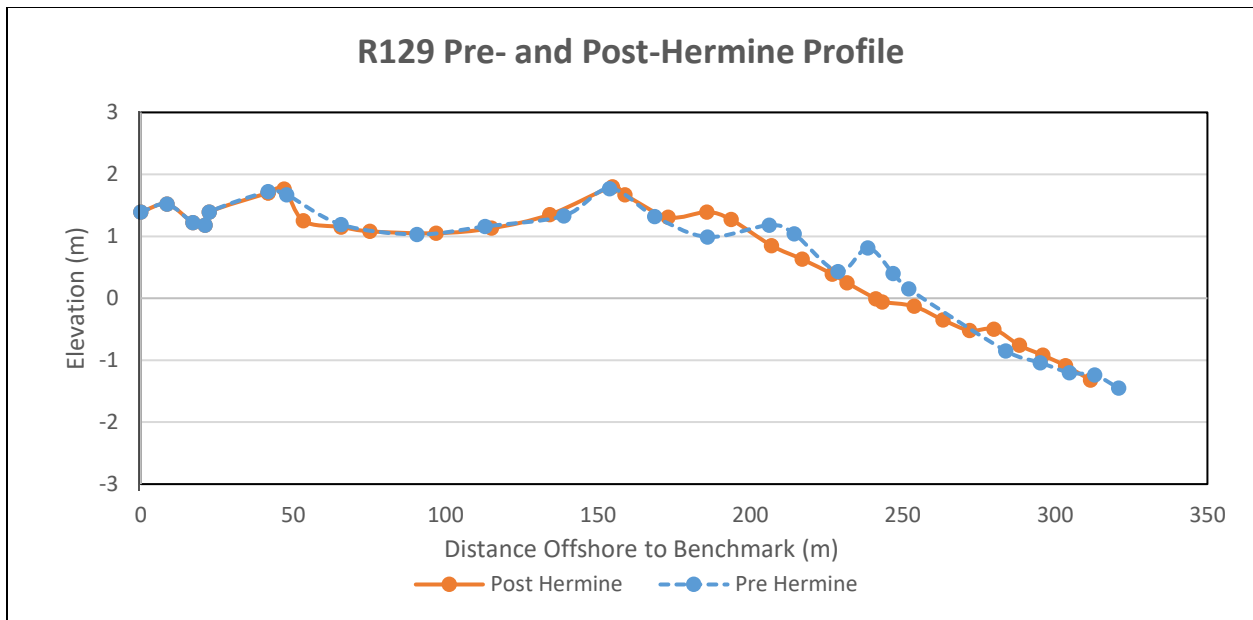
**Figure 40.** Beach profile changes at survey line R129 due to Hermine.

Erosion occurred in the nearshore zone at profile R129 (Figure 40). The pre-storm berm crest at 210 m away from benchmark moved landward for 20 m forming a new storm berm. The pre-storm active berm crest at approximately 240 m away from benchmark was completely eroded away; the nearshore zone gained slight amount of sediment deposition and a subtle sand bar was developed at the location approximately 280 m away from benchmark (Figure 40). The profile change at survey line R133 was similar to the change at R129 (Figure 41). A storm berm was developed at the location approximately 180 m away from benchmark on the pre-storm dry beach; the nearshore zone gained sand; and pre-storm offshore sand bar moved seaward.

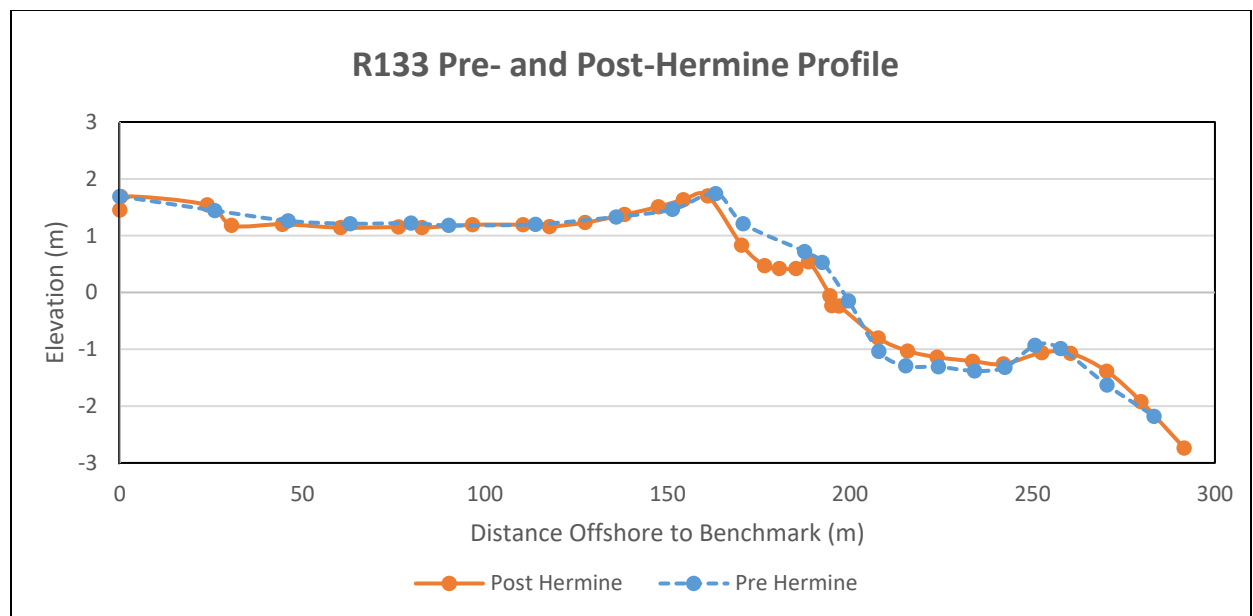
**Figure 41.** Beach profile changes at survey line R133 due to Hermine.

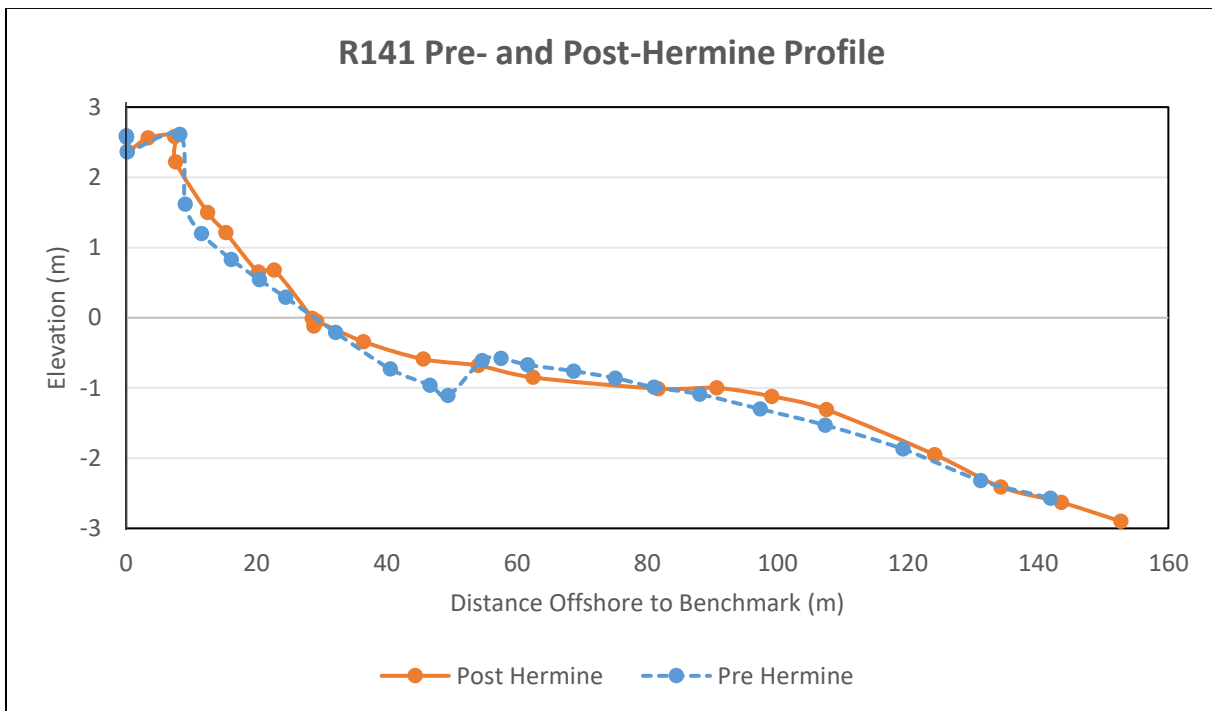
**Figure 42.** Beach profile changes at survey line R141 due to Hermine.

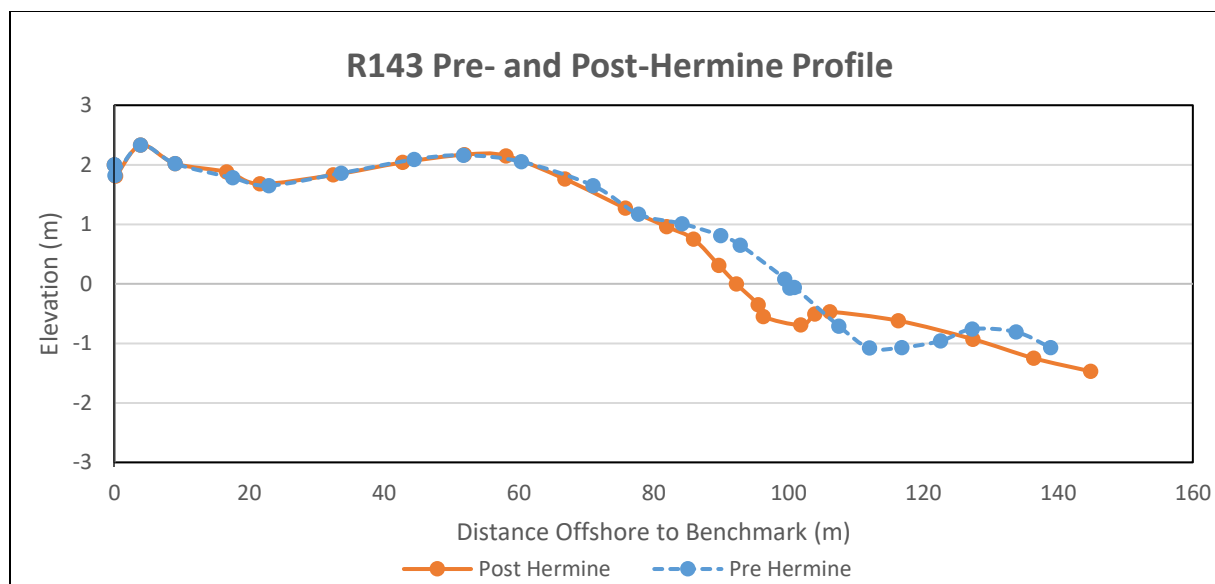
**Figure 43.** Beach profile changes at survey line R143 due to Hermine.

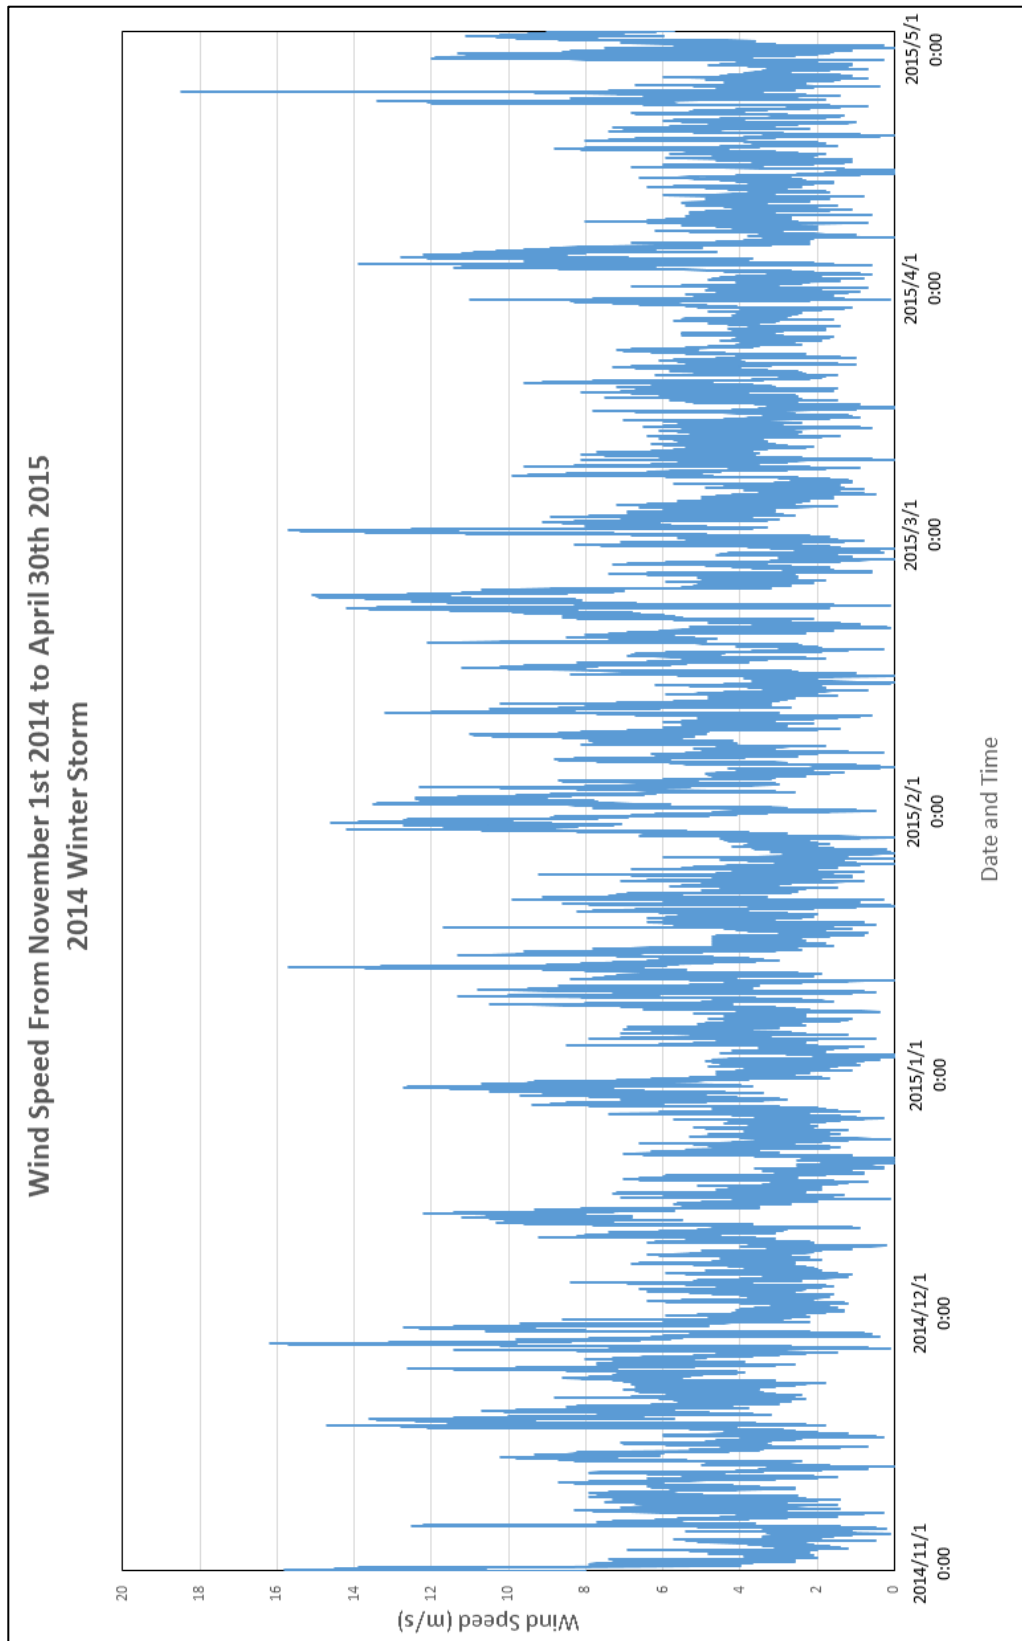
**Figure 44.** Wind speed during the winter of 2014, November 1<sup>st</sup> 2014 to April 30<sup>th</sup> 2015.

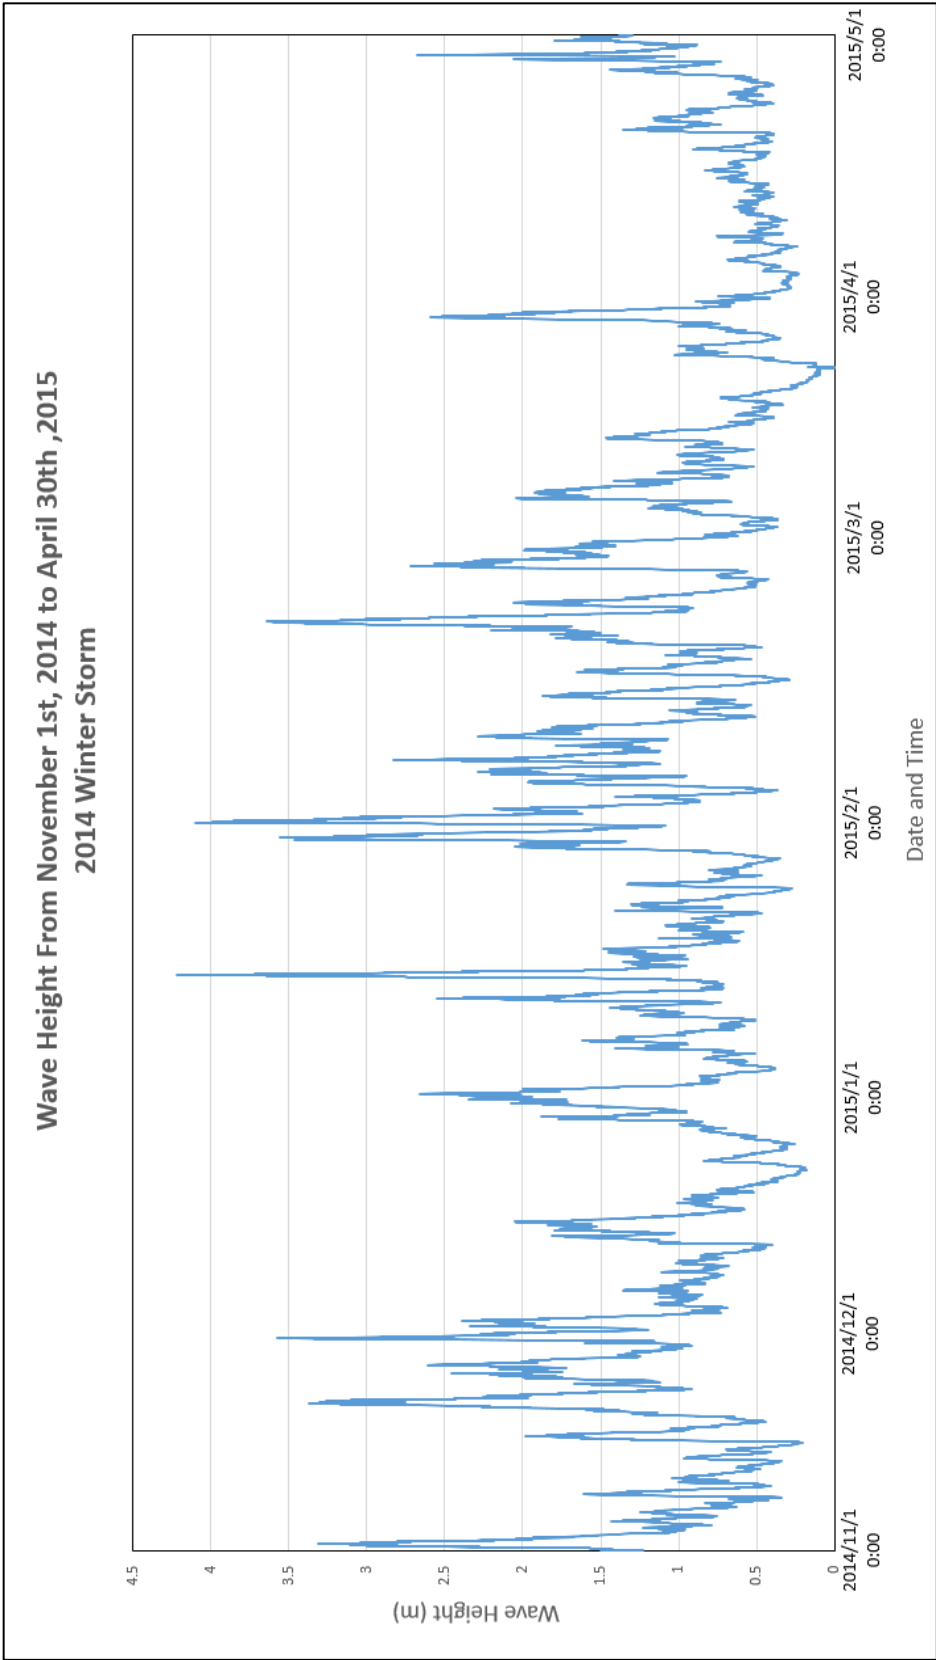
**Figure 45.** Wave height changes during the winter of 2014, November 1<sup>st</sup> 2014 to April 30<sup>th</sup> 2015.

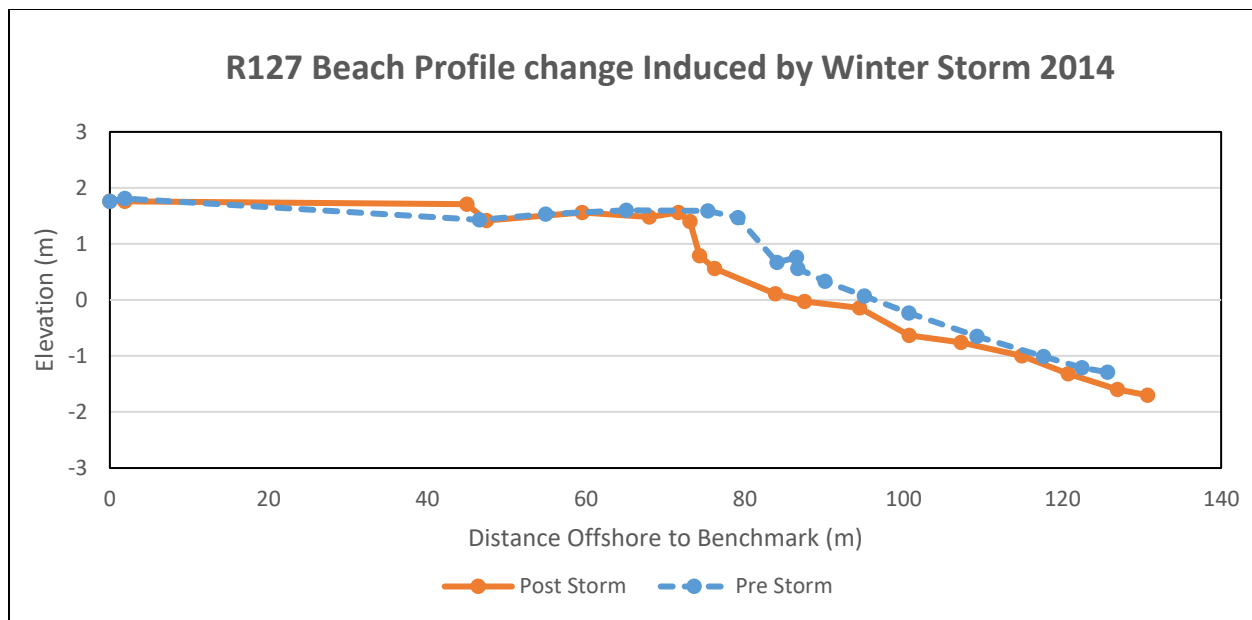
**Figure 46.** Beach profile changes at survey line R127 due to winter storm 2014.

Survey line R127 suffered the most severe erosion along the Treasure Island coast during the 2014 winter season (Figure 46, see page 57). A beach scarp was formed on the dry beach approximately 75 m away from the benchmark. The dry beach was severely eroded, as well as the nearshore zone. At the elevation of 1.0 m, the contour line moved landward for approximately 8 m; at the elevation of 0.0 m, the shoreline was eroded approximately 12 m landward; and at the elevation of -1.0 m, the beach profile retreated approximately 2 m. As discussed previously, beach profile changes at survey line R127 are strongly affected by John's Pass ebb tidal delta. As compared to the beach accretion during tropical storm Hermine in 2016, winds of the winter storm came from the north which generated southward sediment transport. This southward longshore sediment transport resulted in the measured beach erosion.

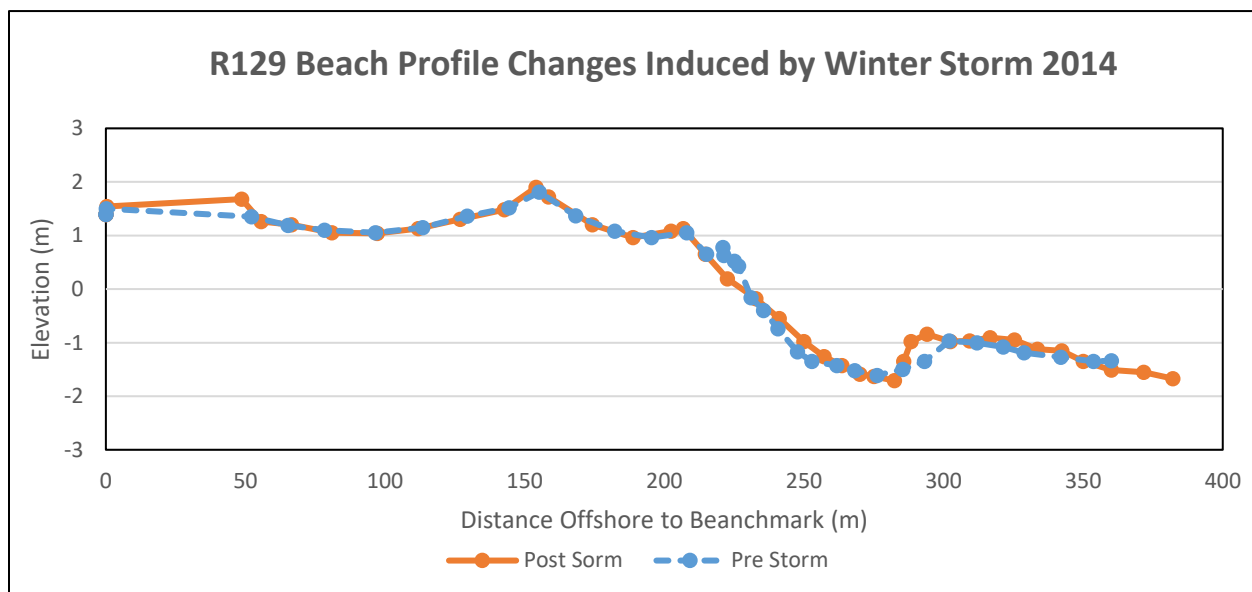
**Figure 47.** Beach profile change at survey line R129 due to winter storm 2014.

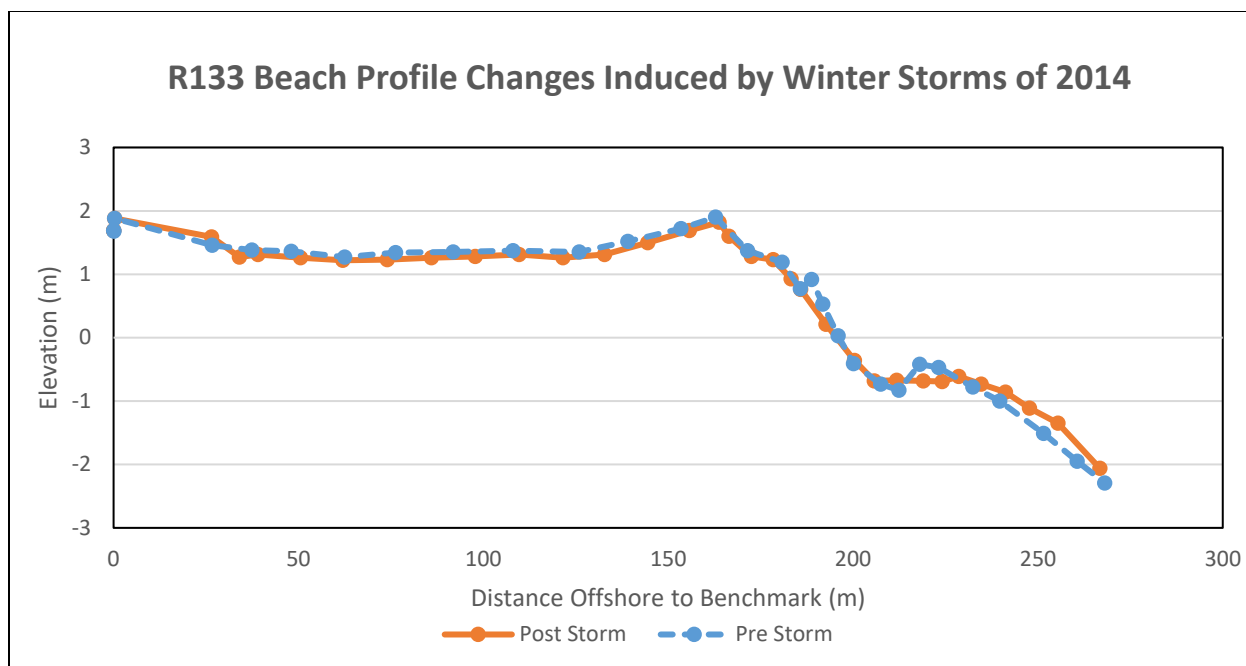
**Figure 48.** Beach profile changes at survey line R133 due to winter storms of 2014.

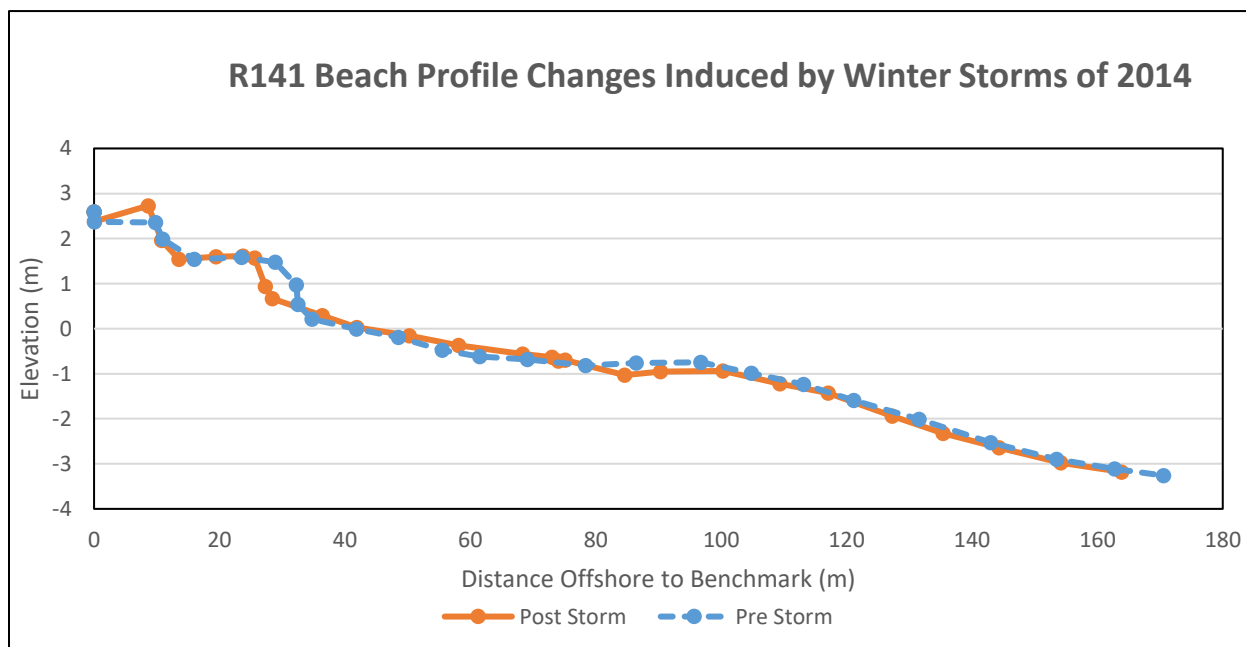
**Figure 49.** Beach profile changes at survey line R141 due to winter storms of 2014.

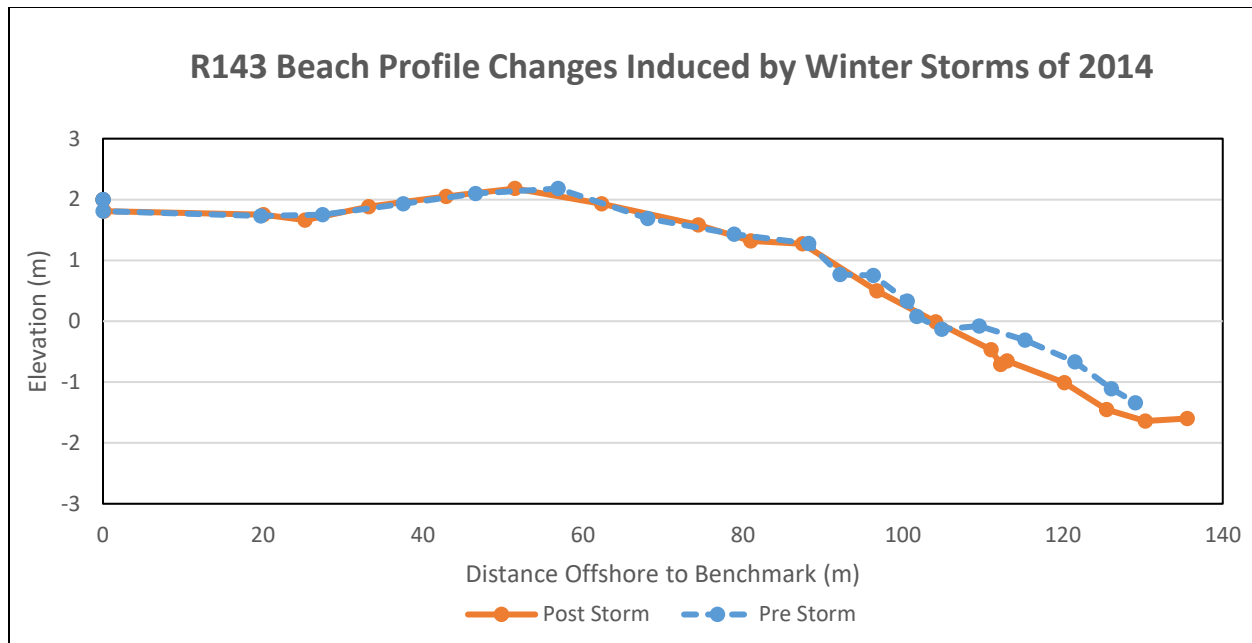
**Figure 50.** Beach profile changes at survey line R143 due to winter storms of 2014.
